Manhole Inspection Summary

Manhole # S29Q__026MH

Insp Date: **4/6/09 7:40 AM**

Location Address: **1310 W OSTEND ST**

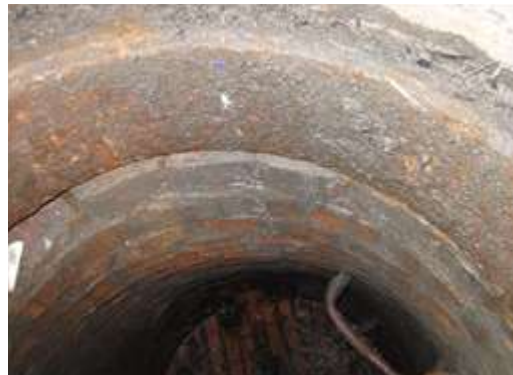
Defect 4

☒ **Leaks**

Infiltration: ☐ None ☐ Joint ☐ Cracks ☒ **Mortar** ☐ Roots ☐ Wall

LID/FRAME INFILTRATION

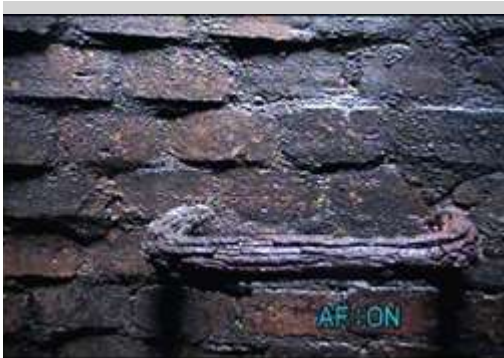
Defect 1

☒ **Corroded**

CORRODED rungs

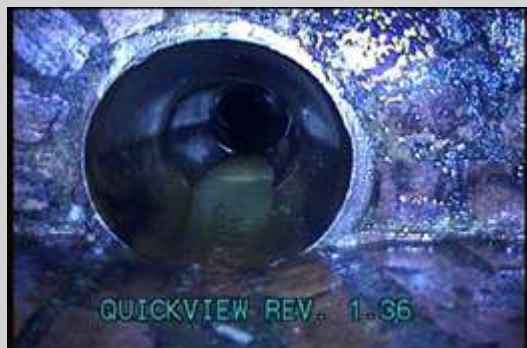
12 O'Clock Outflow

8 in. Circular Gravity Sewer
Pipe Out @ 12 O'Clock
